HD465-8 / HD605-8 Rigid Truck (Tier 4 final engine)

Extended Idle Procedure

(ambient temp below 0°C)

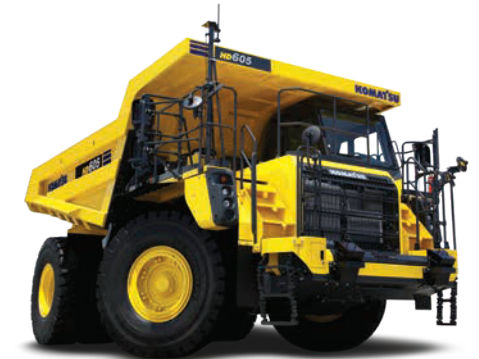
It is recommended under normal operating conditions the AISS Low Switch (Auto Idle Setting System) is set to the OFF position. This allows the engine to be run at a factory set elevated RPM when the park brake is applied and the coolant temperature is below the specified value to help maintain engine temperature.

In the event that more fine control is required (like when entering a workshop) the AISS switch can be turned ON. This allows the engine rpm to be kept at the lowest setting.
